Subject: Final Report Investigation and Recovery Program for Nozzle Port  
Flange Snap Ring Groove Cracking Problem of the Minuteman Stage III  
Motor, Report No. MTO-752-50

FINAL REPORT  
INVESTIGATION AND RECOVERY PROGRAM  
FOR  
NOZZLE PORT FLANGE SNAP RING GROOVE CRACKING PROBLEM  
OF THE  
MINUTEMAN STAGE III MOTOR

MTO-752-50

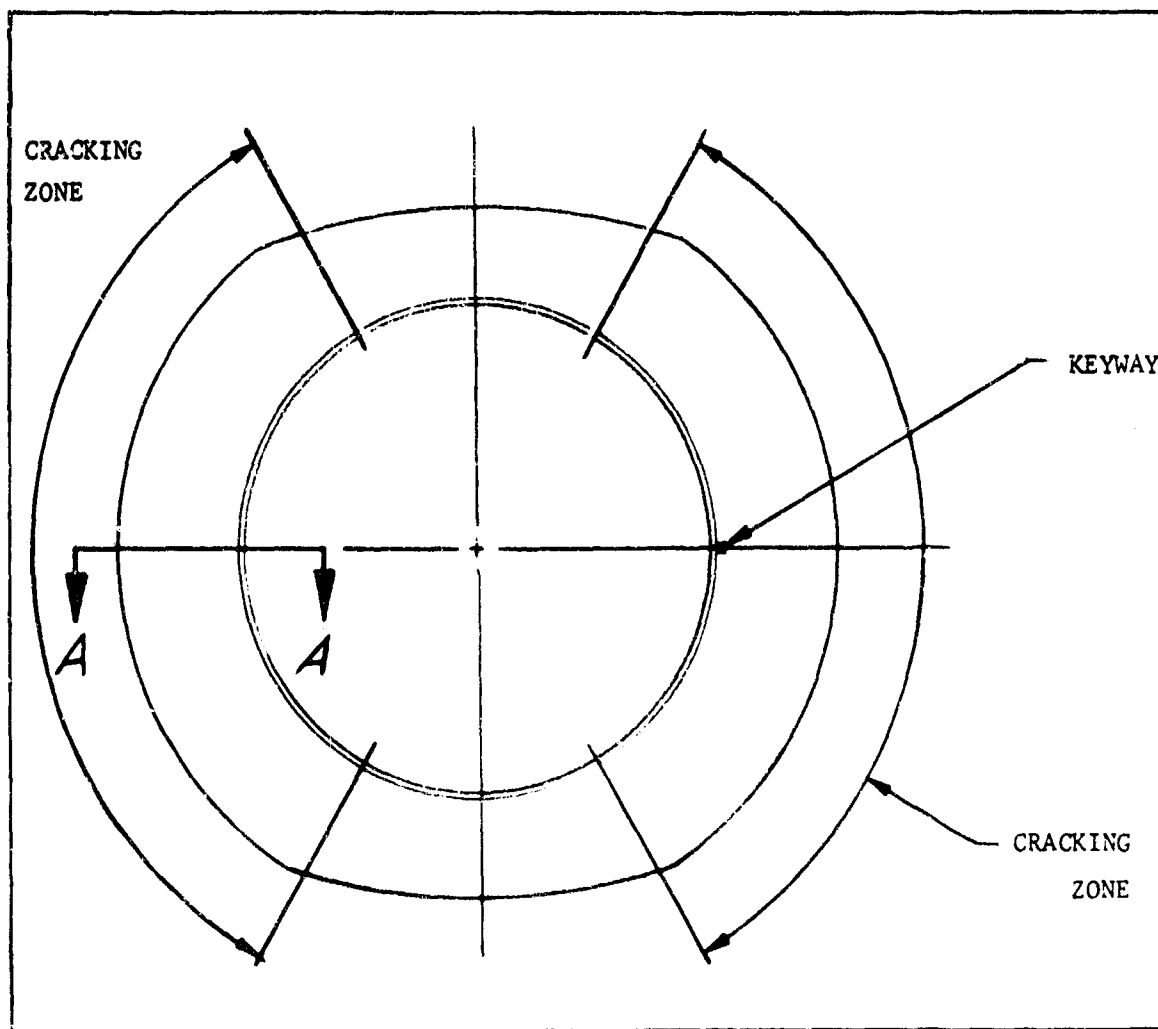
Figure 2. Flange Cracking Zone

Each instance of flange cracking was found to be in the forward radius area of the snap-ring groove at the keyway and/or 180 degrees from the keyway as shown in Figures 1 and 2. These cracks were found to be a maximum of ten inches in circumferential length.

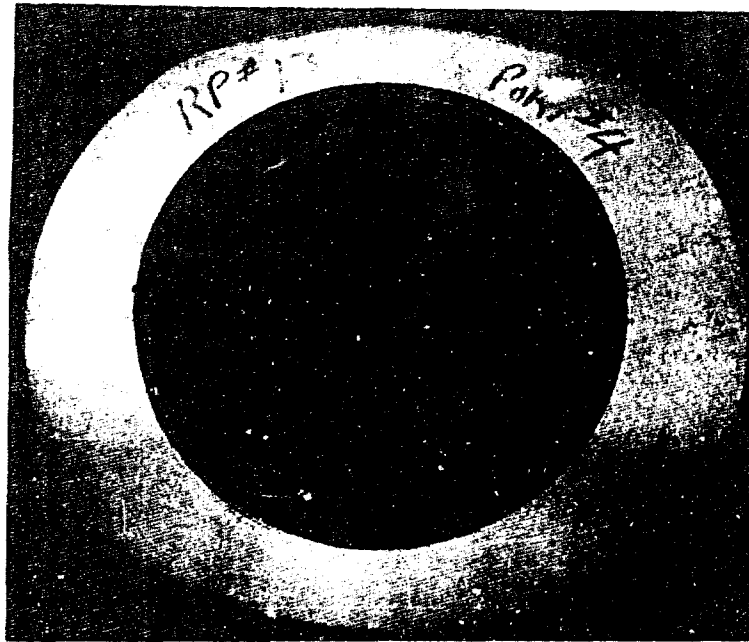
Figure 21. Unfractured Adapter (1/5 actual size)

No failure occurred in adapter GY 027828  
removed from insulator RP-13, Port No. 4

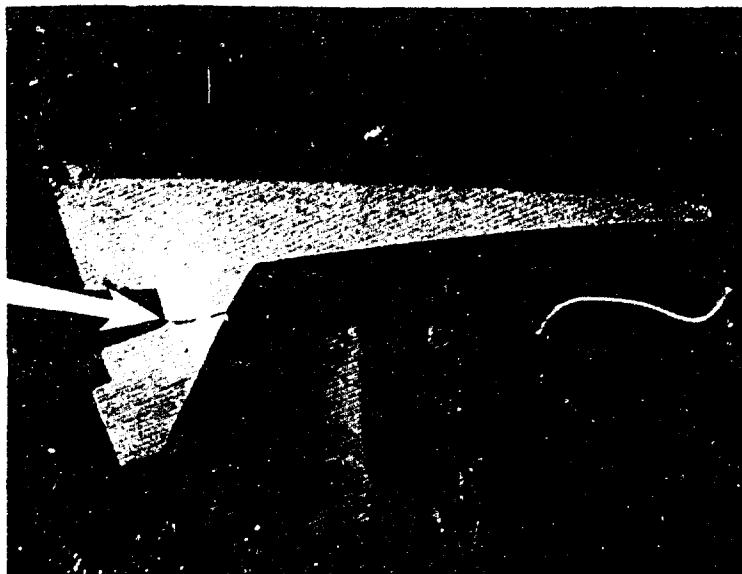
Figure 22. Typical Failure Specimen (Adapter GY 02643, 1-1/5 actual size)

Polished, etched cross section of specimen  
taken 180° from adapter keyway. Arrow points  
to point of origin of fracture.

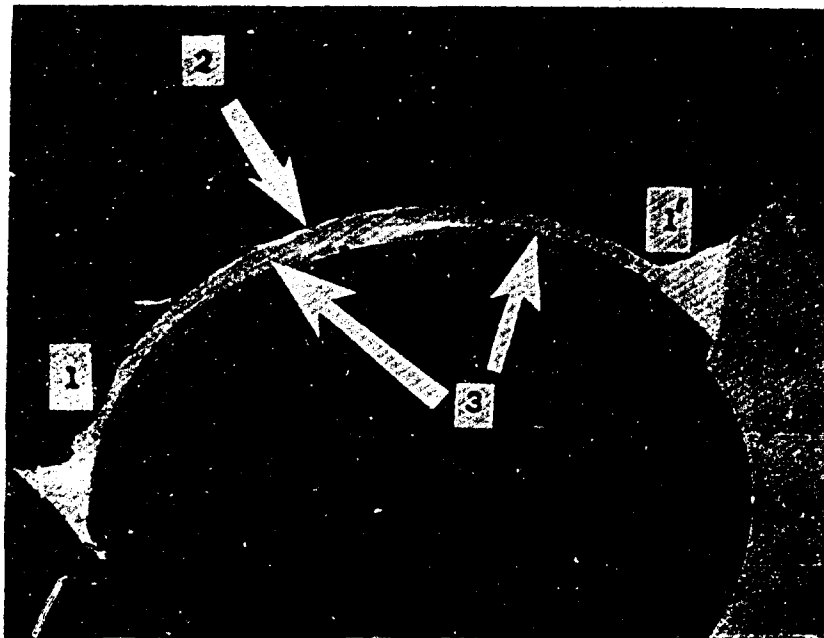
Figure 23. Flange-Failure Sample

Shown (approximately 1/5 actual size) is adapter GY 02508 from Case HP 00429, Nozzle Port 3. The original failure extended from (1) to (1') on the figure. The bright edge indicated by arrow (2) is where shear failure occurred when the fracture was mechanically exposed for surface examination. Arrows (3) point to small shiny, irregular areas extending into the failure surface from the inside edge of the snap-ring groove. These are indications of stress corrosion cracking. The fracture originated in these areas.

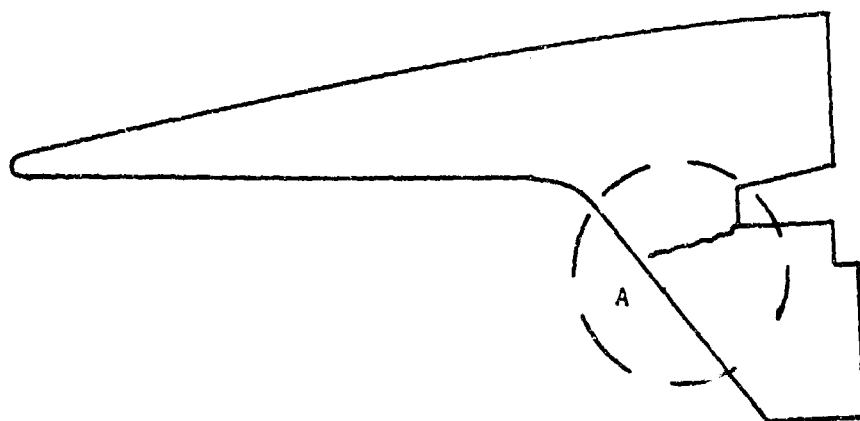
Figure 25. Crack Orientation

Sketch showing general orientation and length of crack  
in Kaiser hand-forged flanges. Crack extends to approx-  
imately  $3/32$  in. of the outboard edge of the flange  
(area A on sketch).

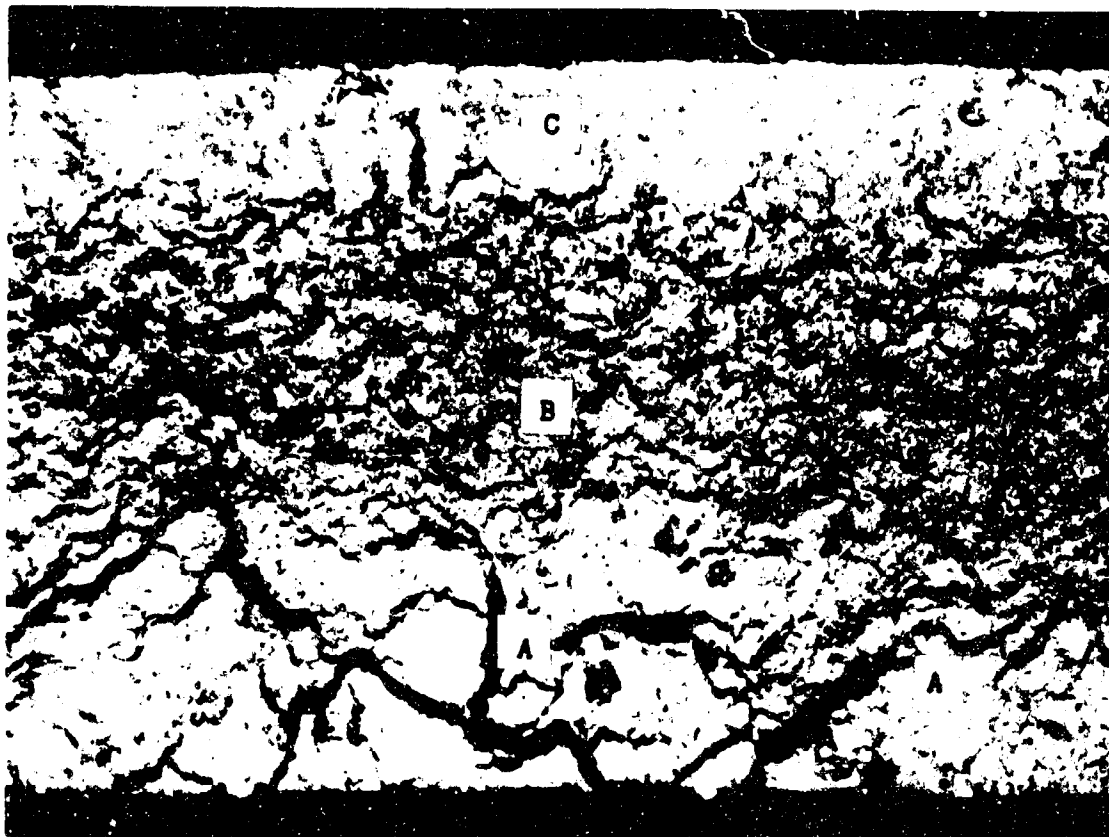
Figure 28. Fracture Surface

Section of fracture surface taken from cracked aluminum alloy (2014-T652) adapter GY 02508. The adapter was installed in Case HP 00429, Nozzle Port 3.

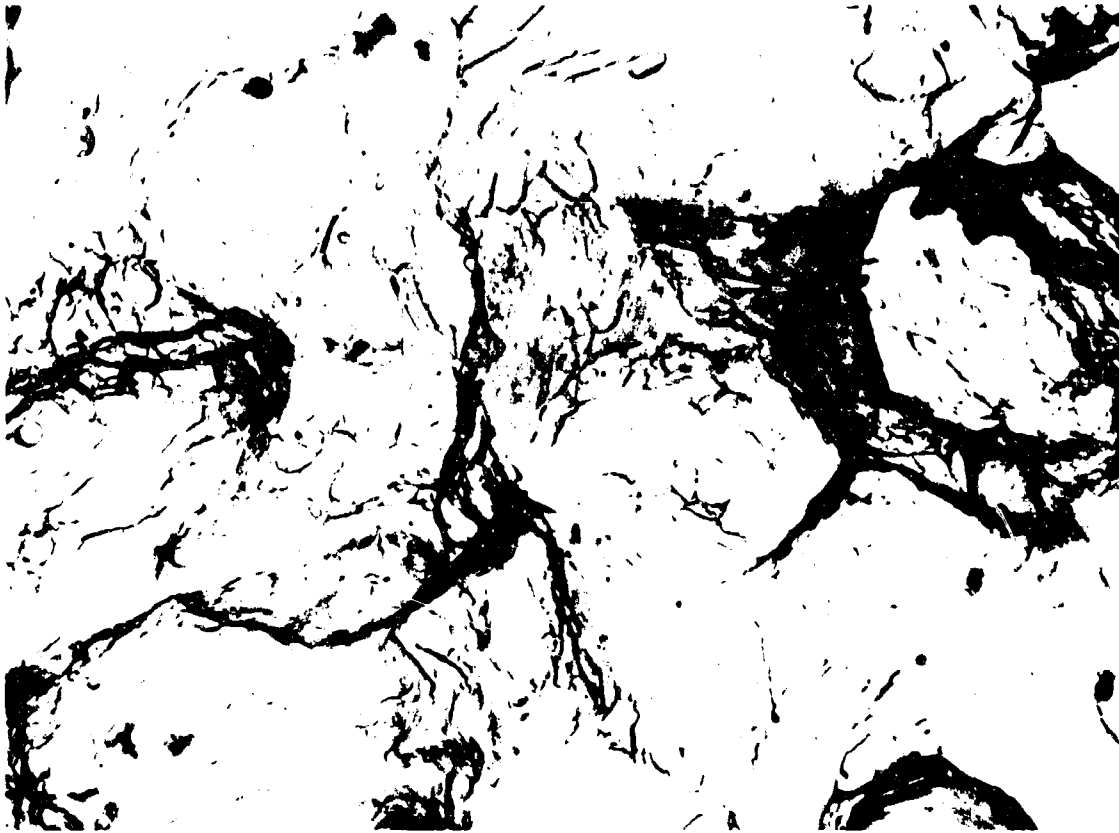
Figure 29. Typical Corrosion Fracture

This is a classical example of stress corrosion cracking on the fracture surface of aluminum alloys. Note flat planar structure with grain intersections approximating  $120^\circ$ .

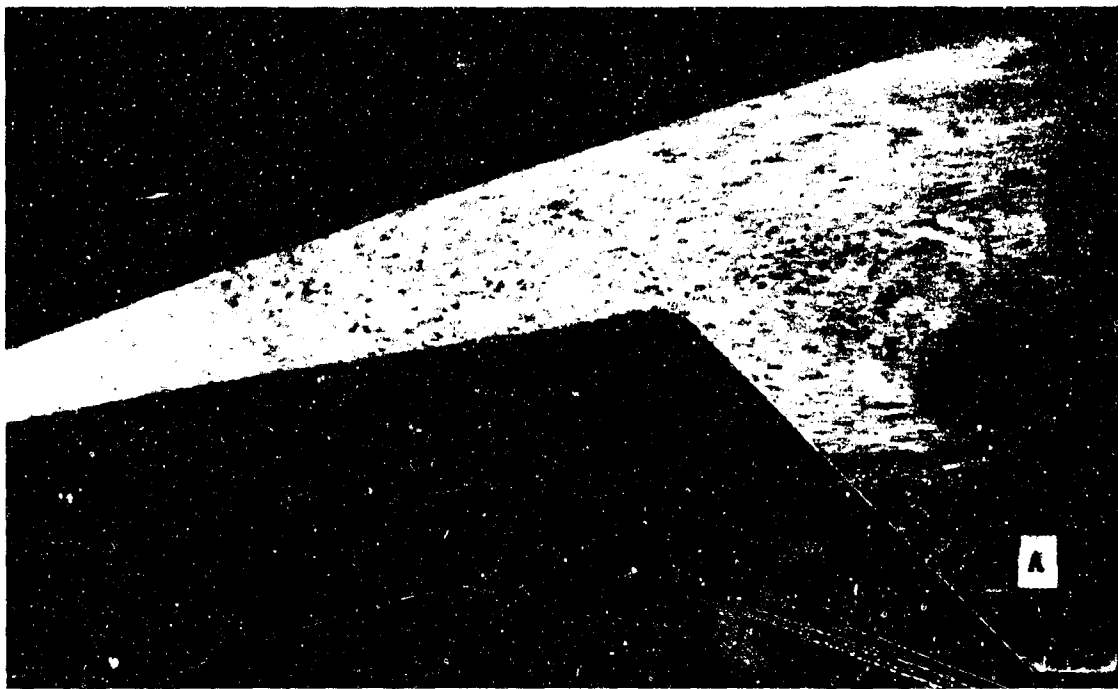
Top photomicrograph shows typical grain flow lines of a Goodyear adapter machined from a Kaiser hand-forged billet (type in which fracture has occurred).

Bottom photomicrograph shows typical grain flow line configuration of an adapter machined from a Kaiser die forging.

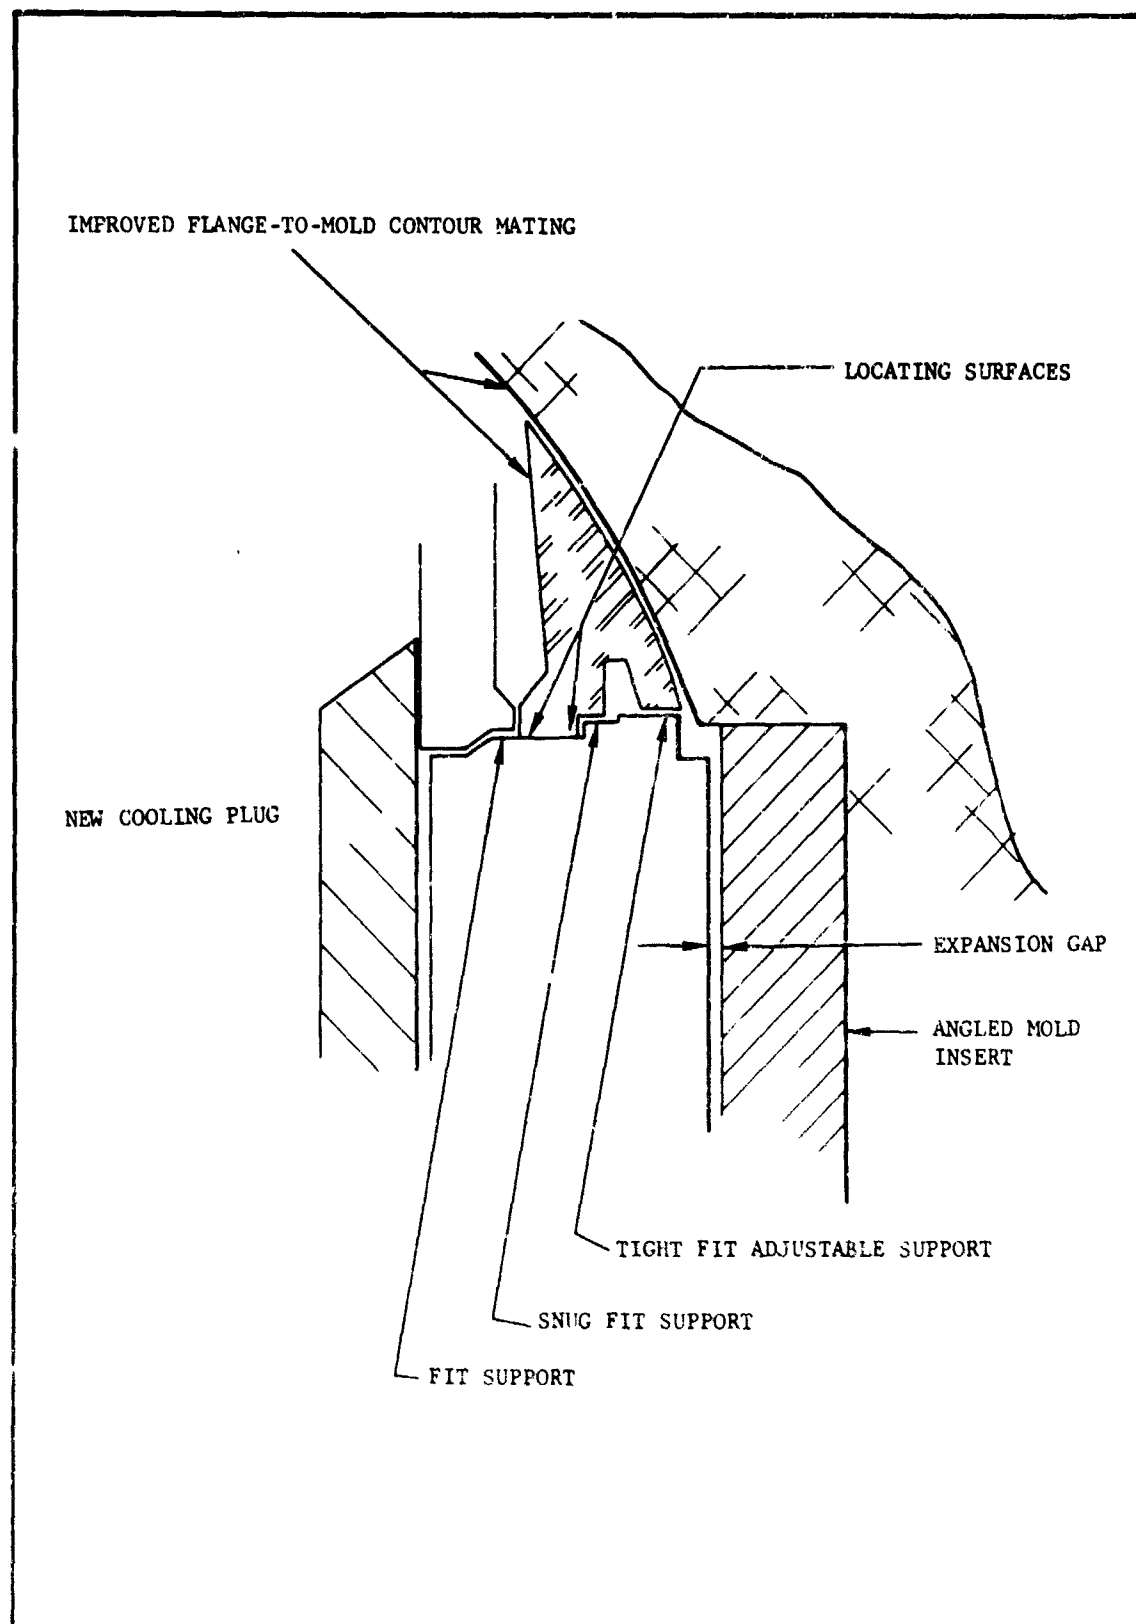
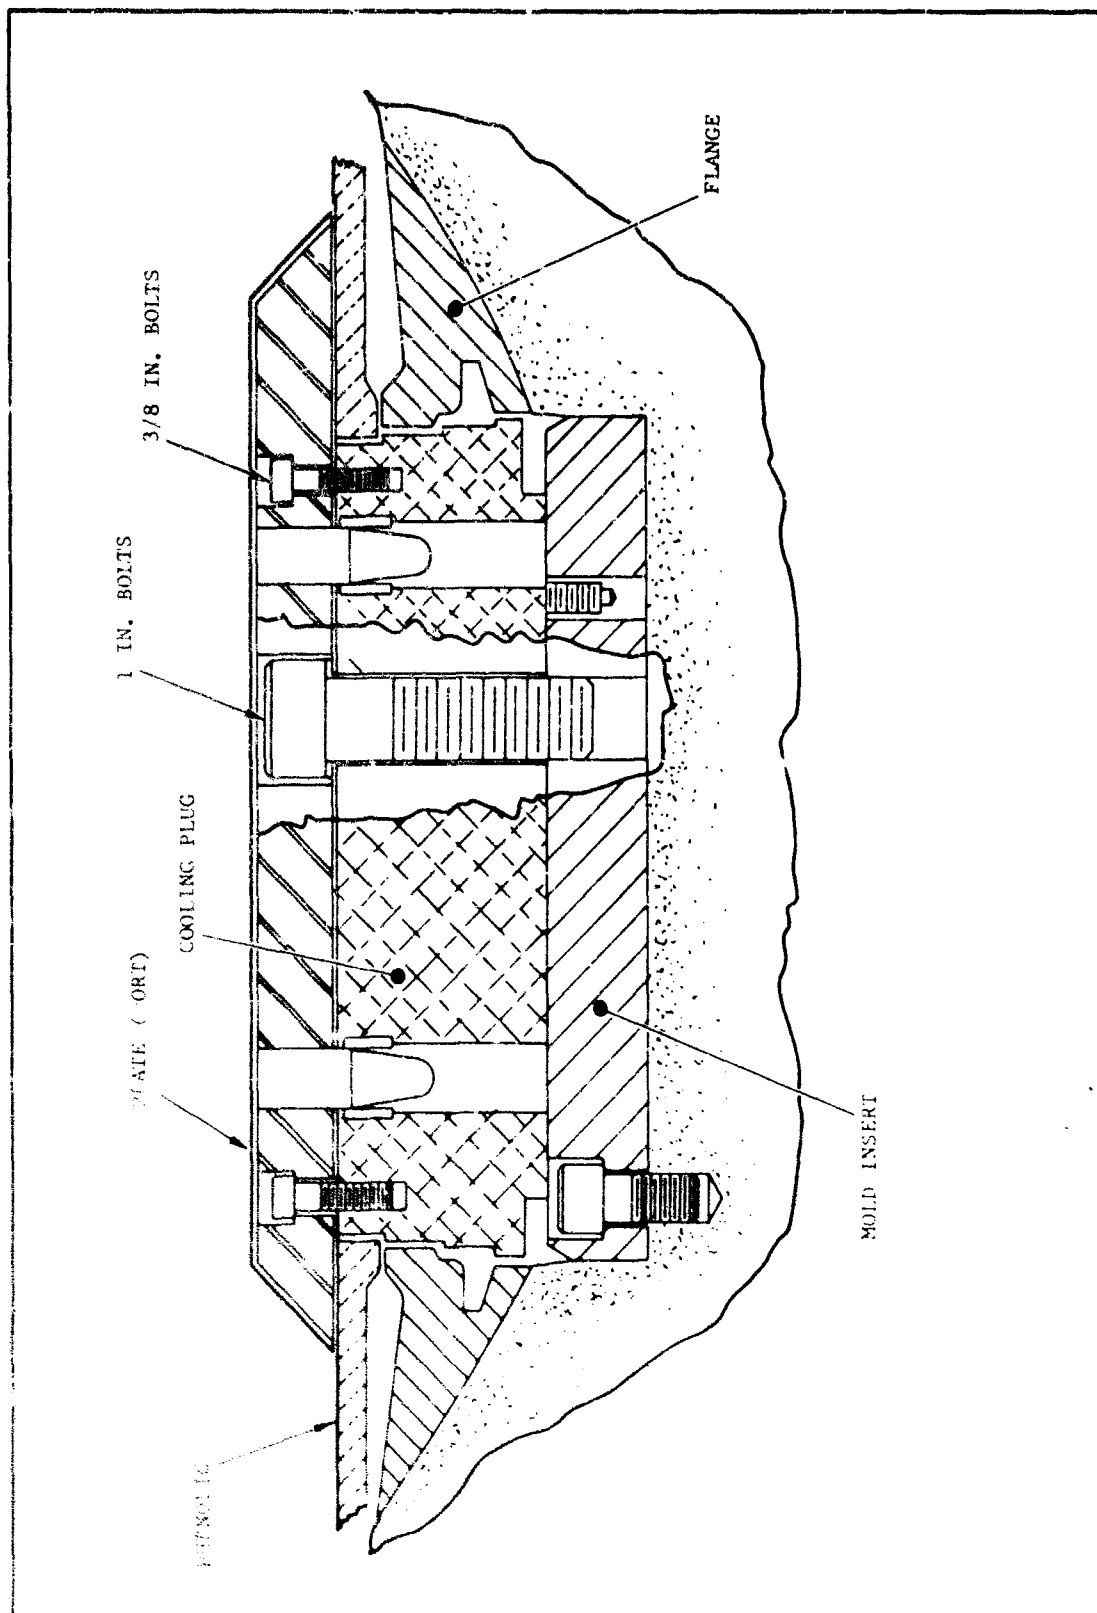
Figure 35. Flange-to-Mold Contour with Modified Cooling

Zyglo and metallurgical tests performed after molding indicated no cracks or stress corrosion in any of the flanges.

To minimize the effects of this contour mismatch, the following changes were incorporated and tested on RP-5 (Figures 35 and 36):

- a. A .081 in. shim was placed on each mold insert, thus leaving approximately 0.020 in. expansion gap between the mold insert and the cooling plug.
- b. After insertion of the cooling plug in each flange, gaps were shimmed between the flange and the cooling plugs on the 10.530 in. diameter. (See Figure 37.) Shimming supports the flange against the cooling plug during molding and reduces the stress in the corner of the snap ring groove.
- c. The four one-inch bolts were torqued to 400 in.-lbs to fully seat the flange in the mold, then loosened and retorqued to 150 in.-lbs.
- d. After assembling the flanges in the mold, each 3/8 in. bolt was loosened approximately one-half turn to allow the cooling plug to move with the flange, thereby eliminating stress on the step from the 10.300 in. to the 10.500 in. diameter of the flange.
